BCP I

# BCP Ingredients Plant

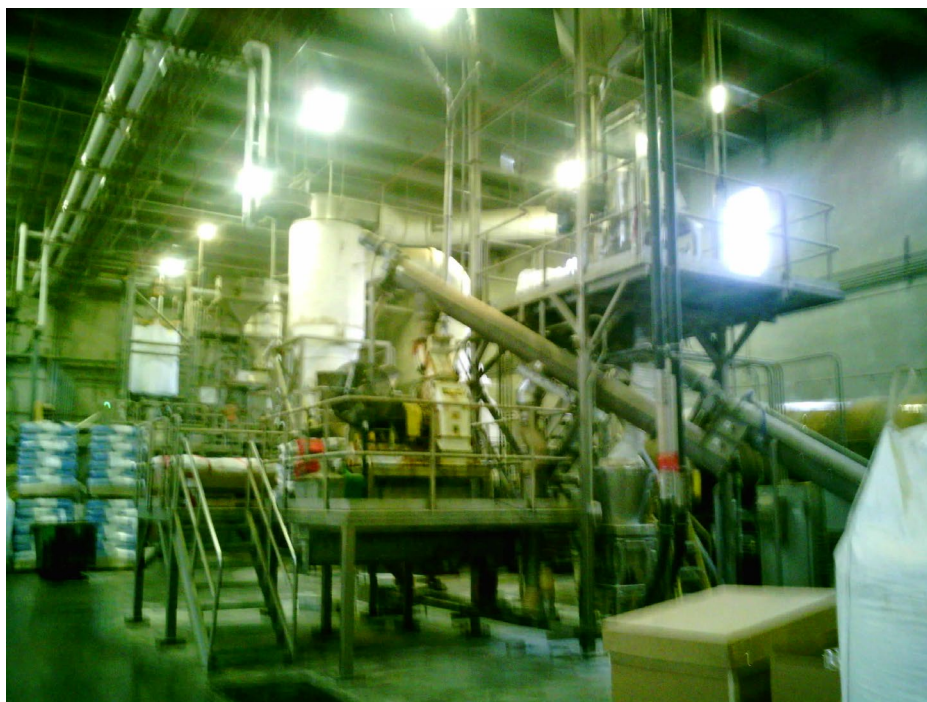
Compliance Evaluation Inspection  Direction: North	DESCRIPTION	Photo inside Building V-26 facing north from the mid-facility wall showing (from back to front) the kiln, hammer mill, and cooler for choline chloride production	Photo 001
	PHOTOGRAPHER	Jodi Harper	Date 06/07/2022

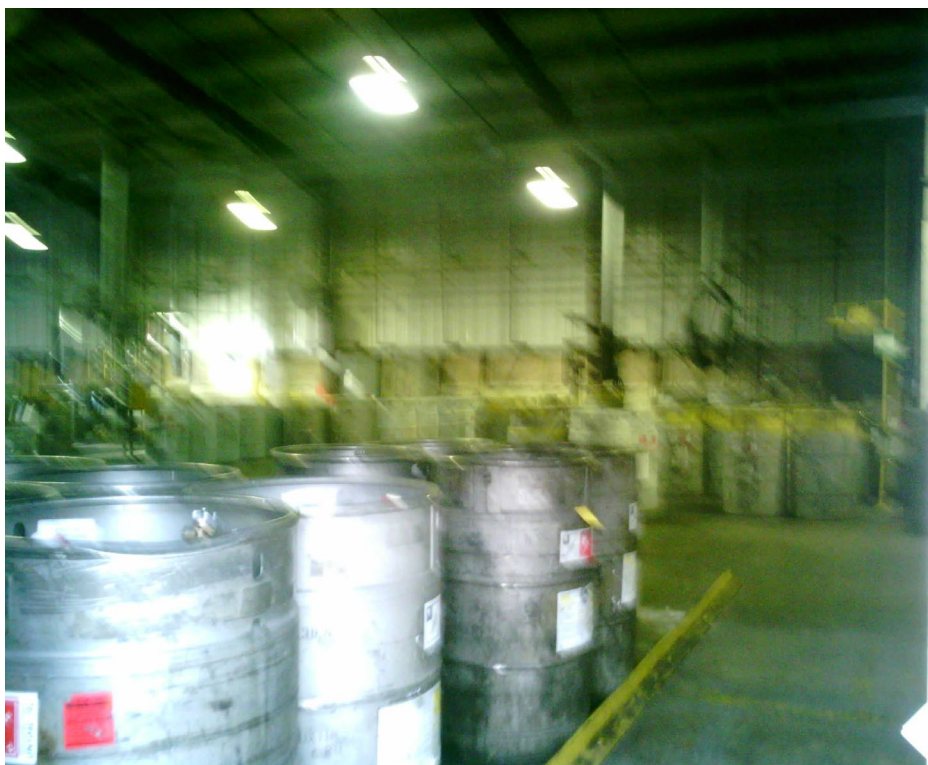
Compliance Evaluation Inspection  Direction: WSW	DESCRIPTION	Photo taken from mid-building door on east side of Building V25, facing west-southwest of the ethylene oxide repackaging warehouse (blurry)	Photo 002
	PHOTOGRAPHER	Jodi Harper	Date 06/07/2022

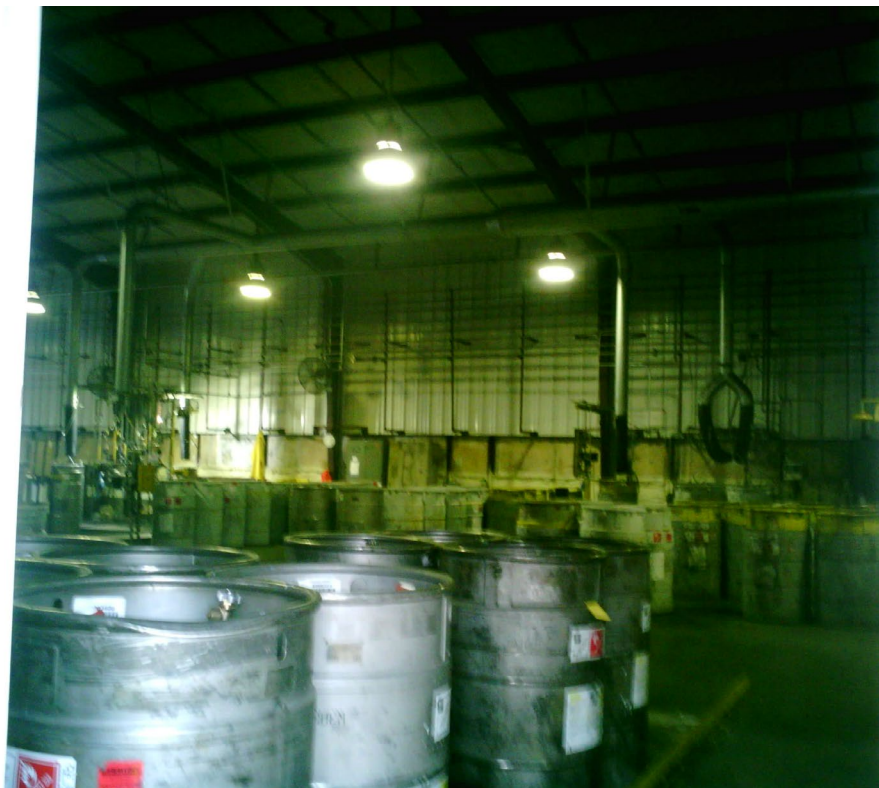
Compliance Evaluation Inspection  Direction: WSW	DESCRIPTION	Photo taken from mid-building door on east side of Building V25, facing west-southwest of the ethylene oxide repackaging warehouse	Photo 003
	PHOTOGRAPHER	Jodi Harper	Date 06/07/2022

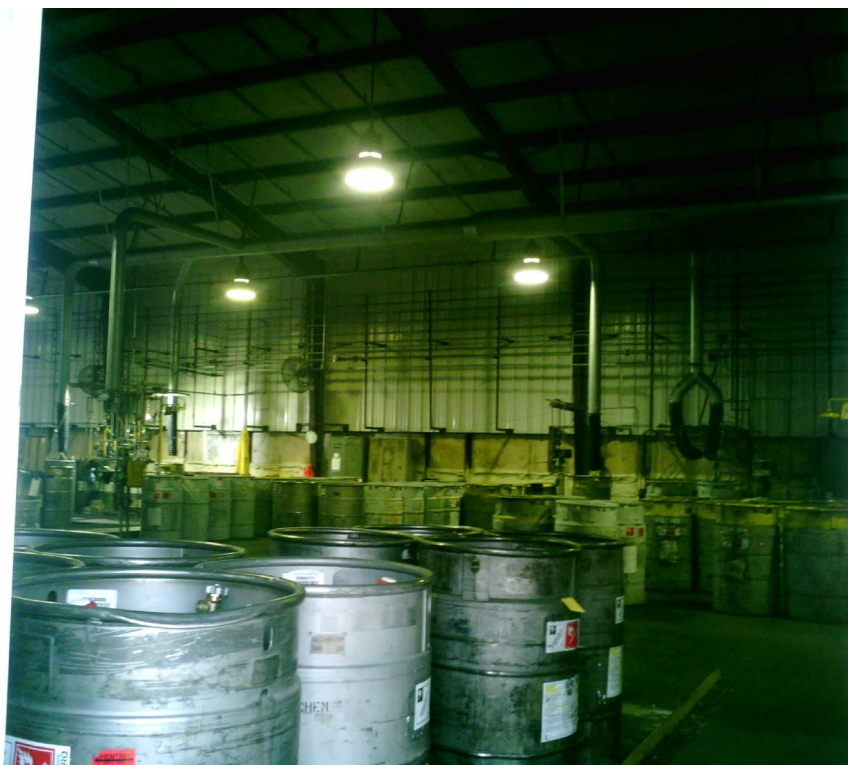
Compliance Evaluation Inspection  Direction: WSW	DESCRIPTION	Photo taken from mid-building door on east side of Building V25, facing west-southwest of the ethylene oxide repackaging warehouse	Photo 004
	PHOTOGRAPHER	Jodi Harper	Date 06/07/2022

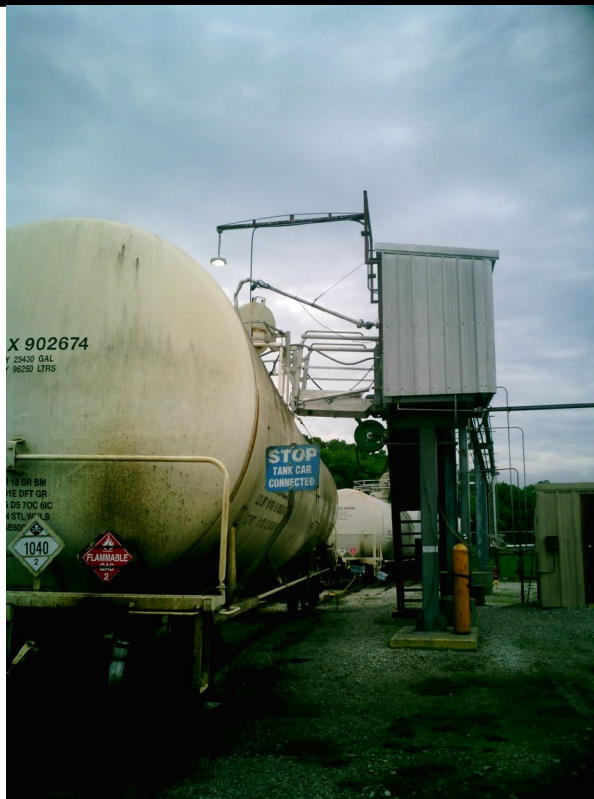
Compliance Evaluation Inspection  Direction: Northwest	DESCRIPTION	Photo looking northwest from end of ethylene oxide railcar at rail offloading station T9A, where April 8, 2022 release occurred.	Photo 005
	PHOTOGRAPHER	Jodi Harper	Date 06/07/2022

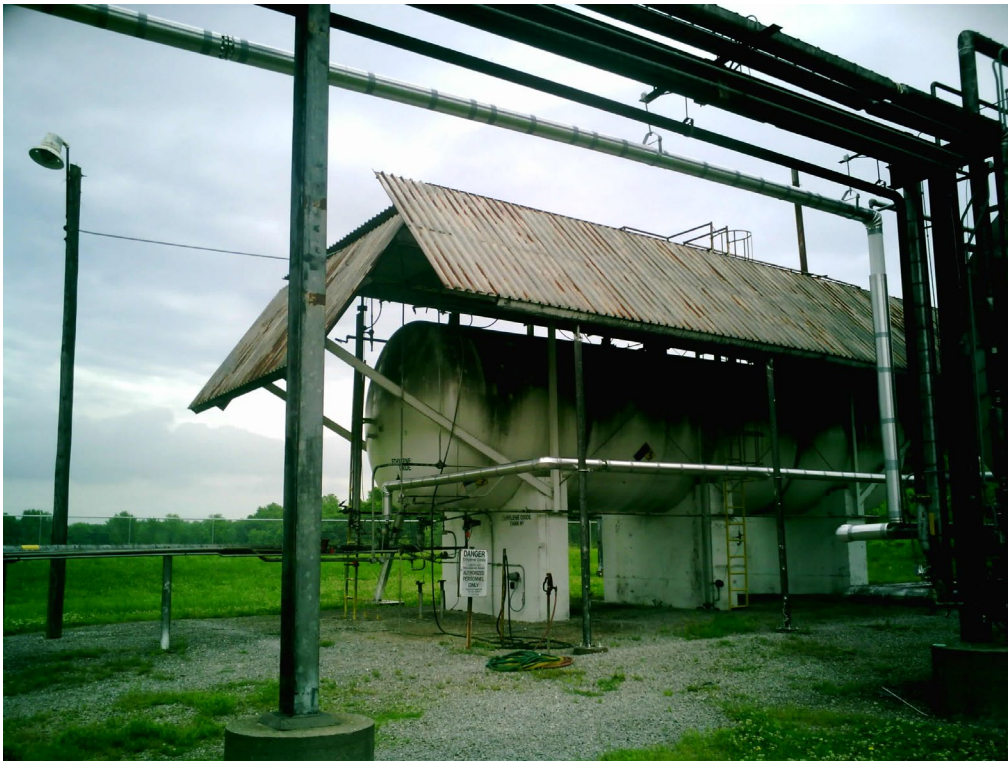
Compliance Evaluation Inspection  Direction: NNE	DESCRIPTION	Photo looking north-northeast from a point west of Tank T2, with a view of Tank T1. Tank T1 was in service at the time of the April 8, 2022, release, but at the time of inspection, was taken out of service.	Photo 006
	PHOTOGRAPHER	Jodi Harper	Date 06/07/2022

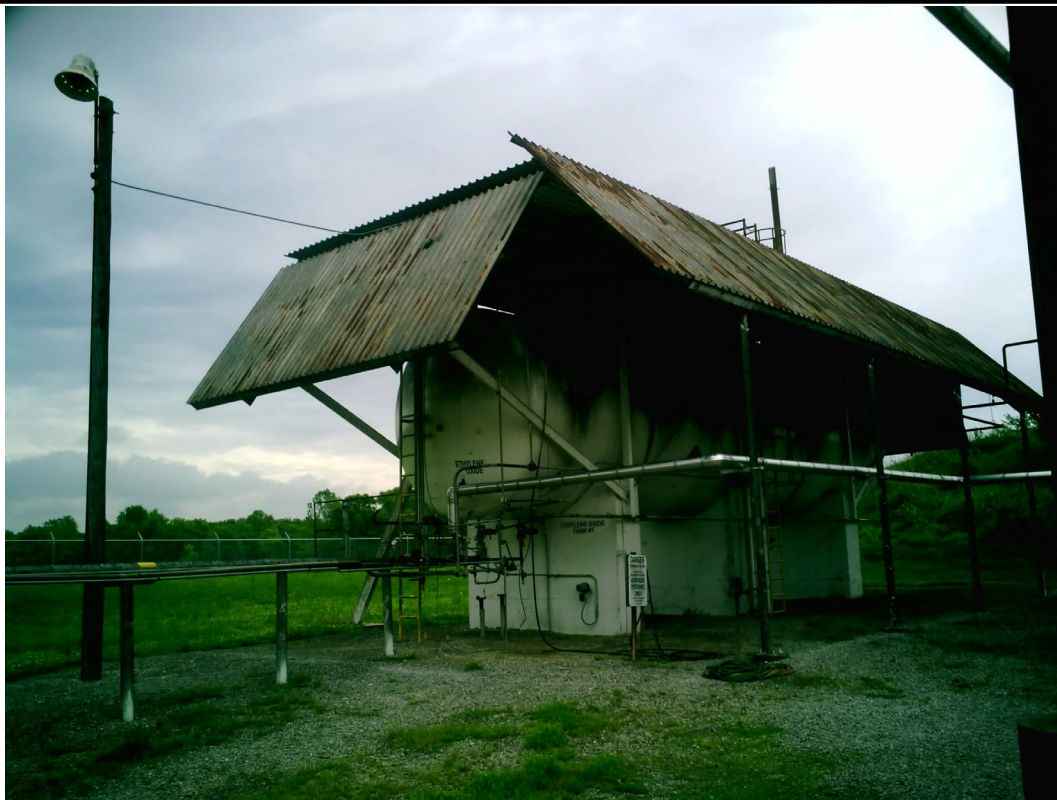
Compliance Evaluation Inspection	DESCRIPTION	Photo looking east-northeast from a point west of Tank T2 with a view of Tank T1. Tank T1 was in service at the time of the April 8, 2022 release, but has since been taken out of service.	Photo 007
	PHOTOGRAPHER	Jodi Harper	Date 06/07/2022

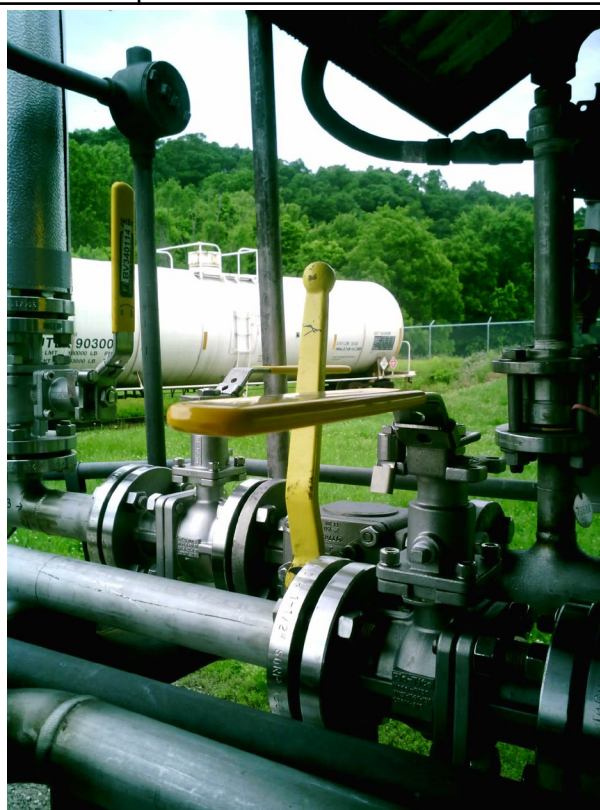
Compliance Evaluation Inspection	DESCRIPTION	Photo looking slightly north of west from underneath the covered area of the ball valve involved in the April 8, 2022 release.	Photo 008
	PHOTOGRAPHER	Jodi Harper	Date 06/07/2022

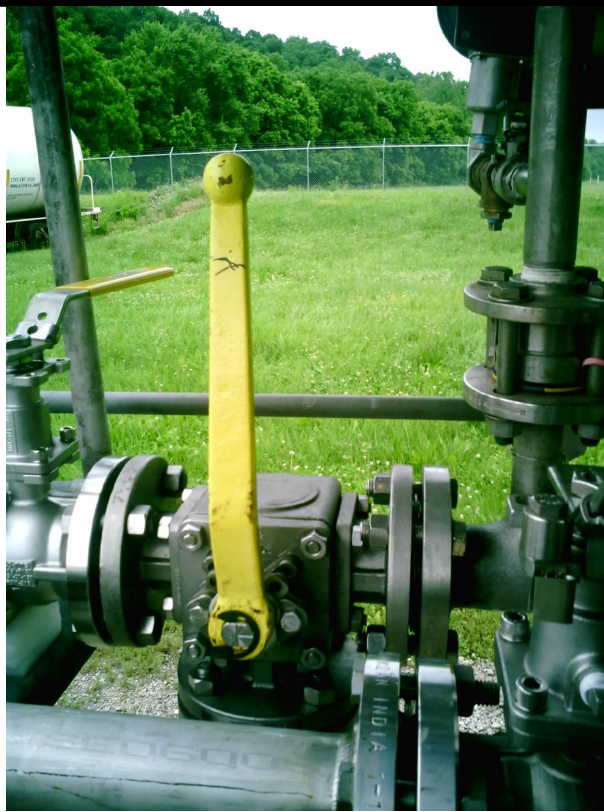
Compliance Evaluation Inspection	DESCRIPTION	Photo looking slightly west of north from under the covered area. Photo is of the ball valve involved in the April 8, 2022 release.	Photo 009
	PHOTOGRAPHER	Jodi Harper	Date 06/07/2022

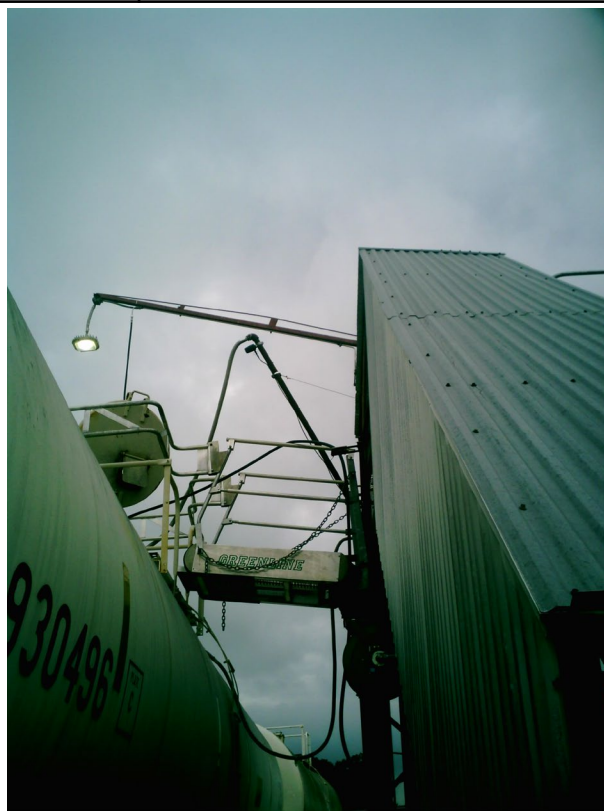
Compliance Evaluation Inspection	DESCRIPTION	Photo looking slightly west of north from the base of the stairs to filling station T9, showing the video monitor for the railcar unloading process.	Photo 010
	PHOTOGRAPHER	Jodi Harper	Date 06/07/2022

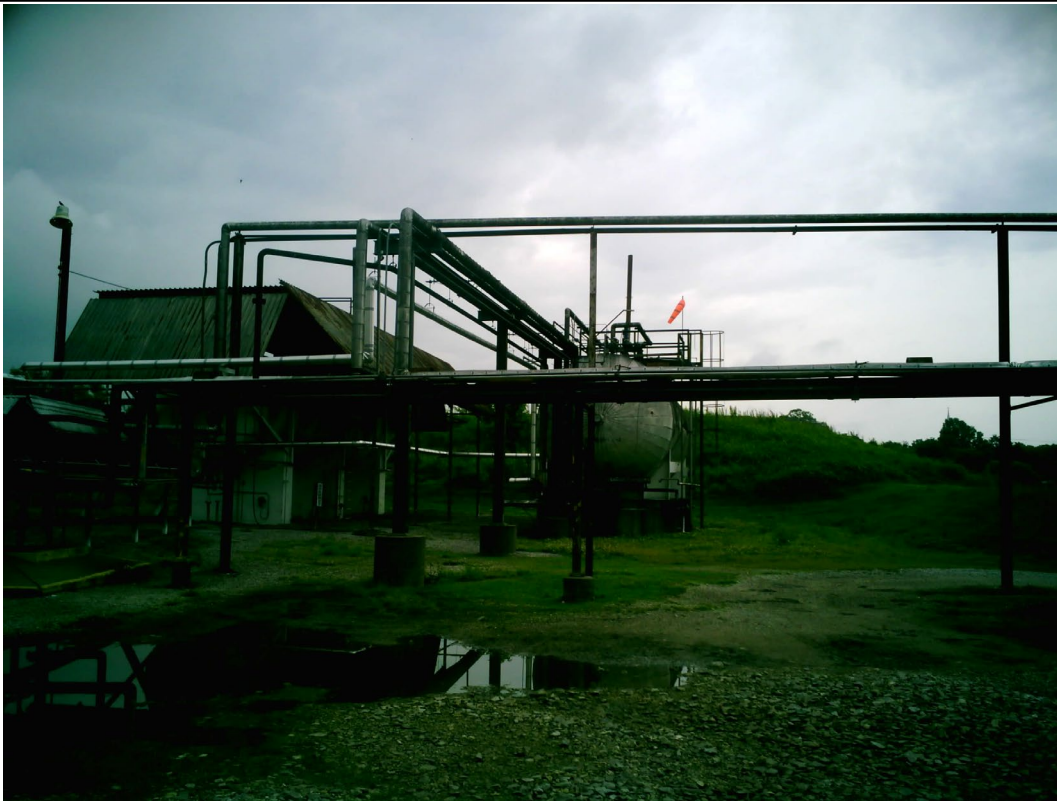
Compliance Evaluation Inspection  Direction: East	DESCRIPTION	Photo looking east from a point south of the covered valve area, looking at Tank T2.	Photo 011
	PHOTOGRAPHER	Jodi Harper	Date 06/07/2022

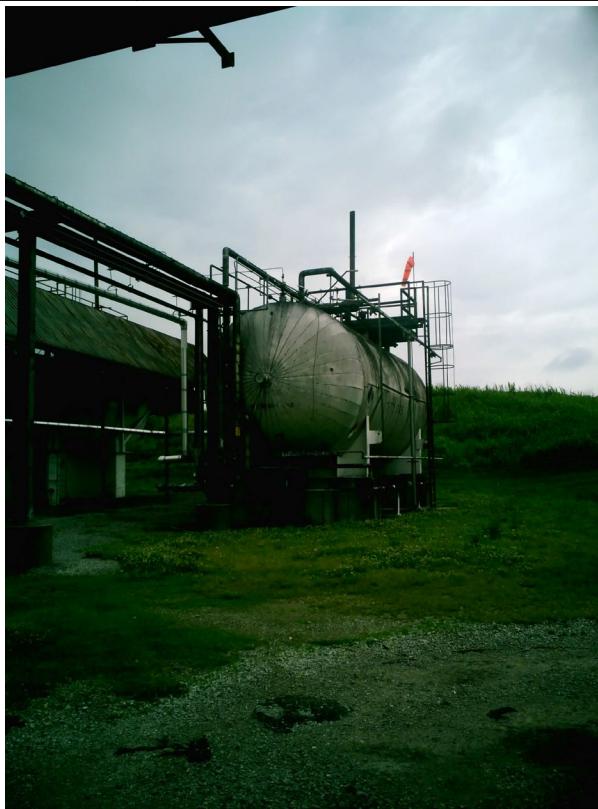
Compliance Evaluation Inspection  Direction: East	DESCRIPTION	Photo looking east from a point about 10 feet closer to Tank T2 than in photo 011, above, of Tank T2.	Photo 012
	PHOTOGRAPHER	Jodi Harper	Date 06/07/2022

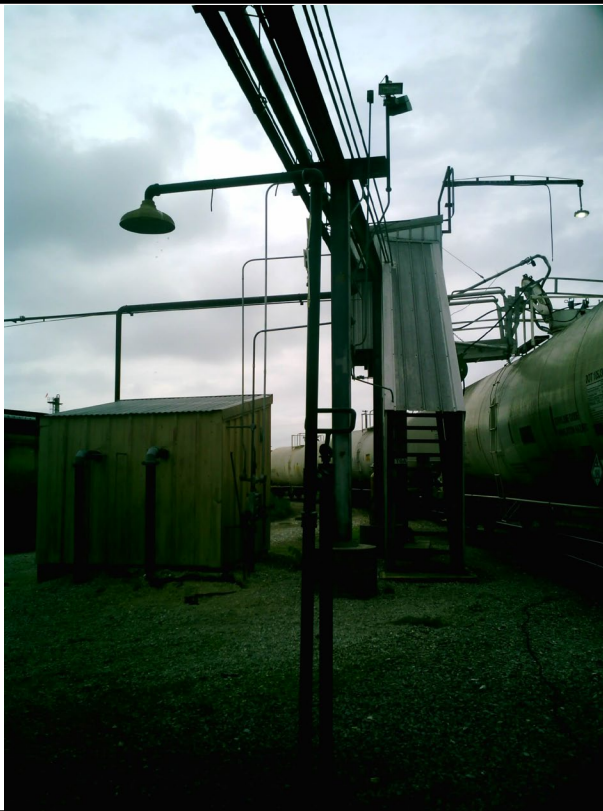
Compliance Evaluation Inspection	DESCRIPTION	Photo looking south from a point just north of the emergency shower, of the emergency shower at the railcar unloading station.	Photo 013
	PHOTOGRAPHER	Jodi Harper	Date 06/07/2022

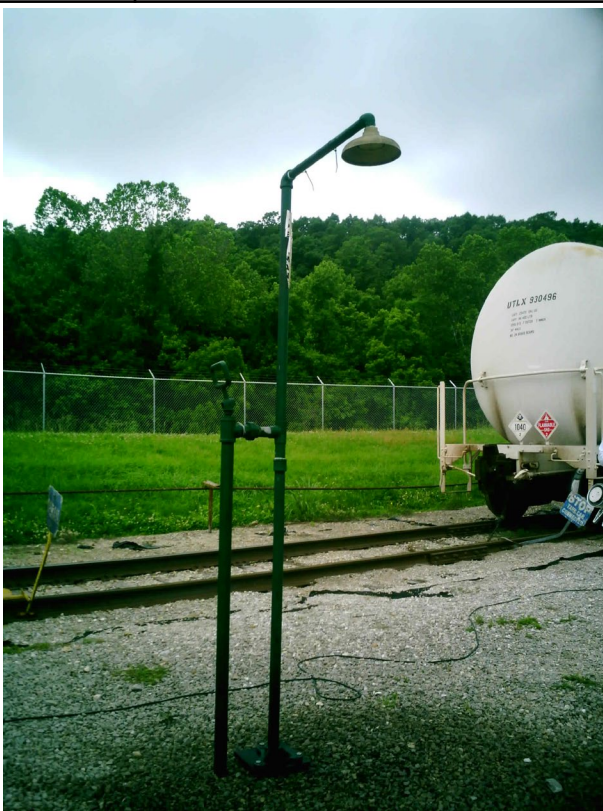
Compliance Evaluation Inspection	DESCRIPTION	Photo looking west from a point east of the emergency shower, of the emergency shower at the railcar unloading station. Facility personnel demonstrated that the emergency shower was operational.	Photo 014
	PHOTOGRAPHER	Jodi Harper	Date 06/07/2022

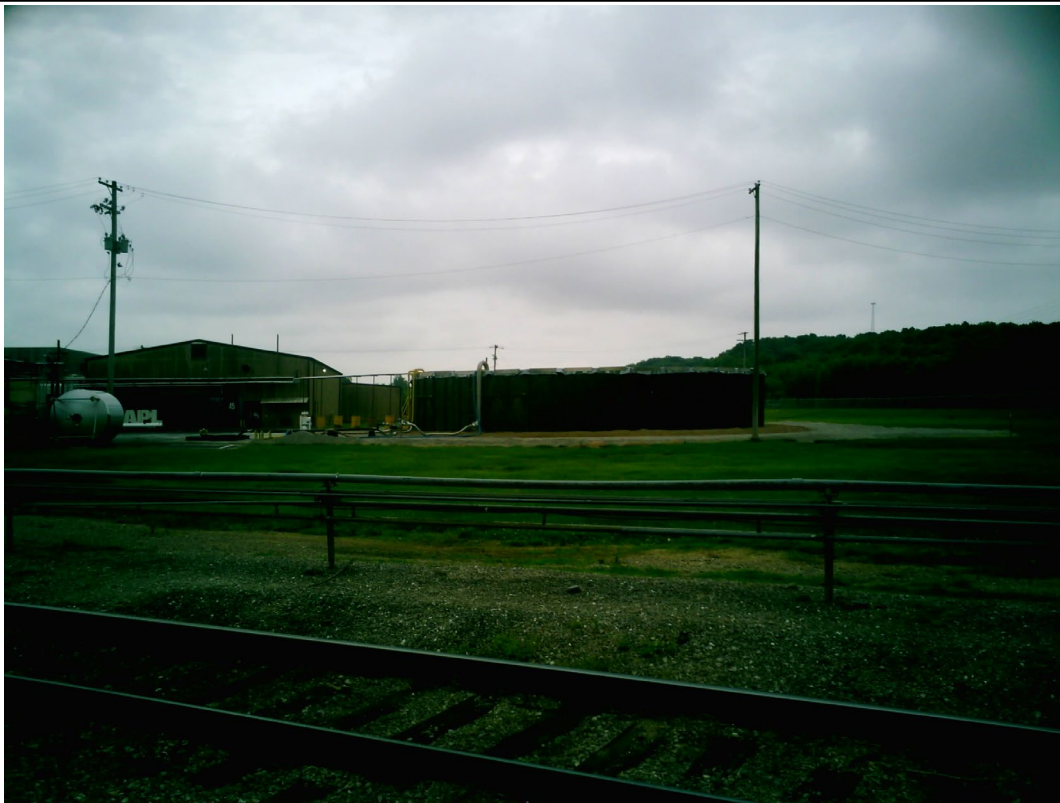
Compliance Evaluation Inspection	DESCRIPTION	Photo looking southwest from a point along the rail spur at the temporary wastewater holding basin.	Photo 015
	PHOTOGRAPHER	Jodi Harper	Date 06/07/2022

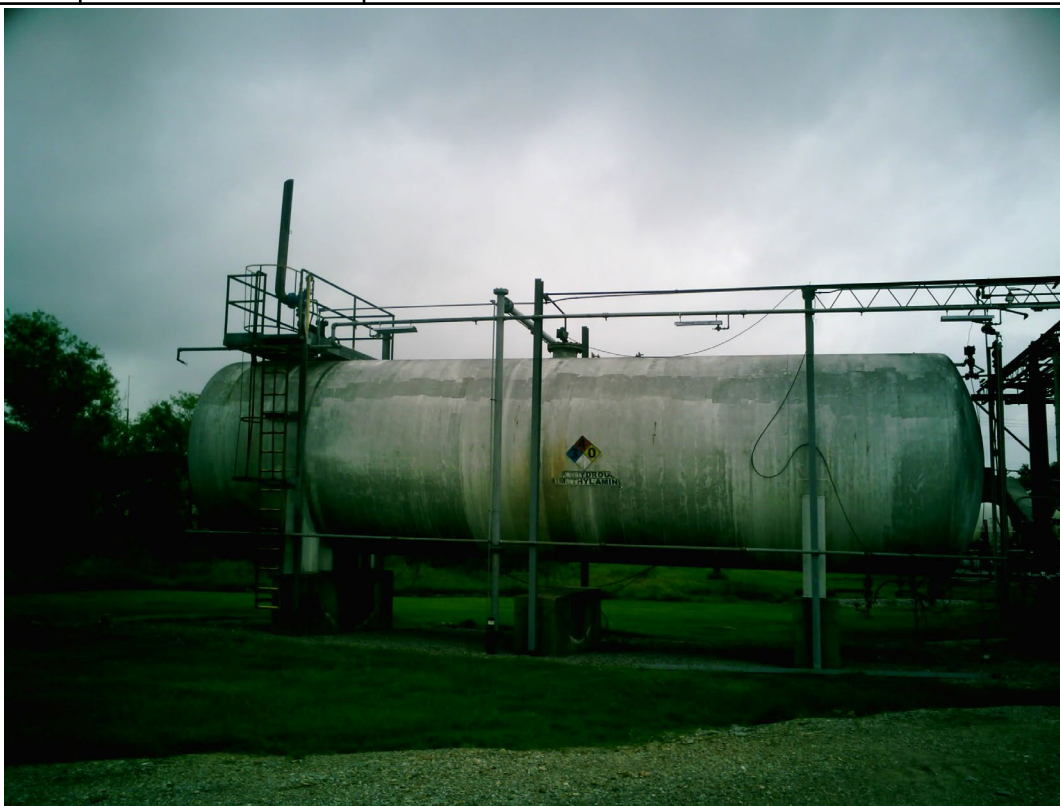
Compliance Evaluation Inspection	DESCRIPTION	Photo looking east from west of the trimethylamine storage tank of storage tank.	Photo 016
	PHOTOGRAPHER	Jodi Harper	Date 06/07/2022

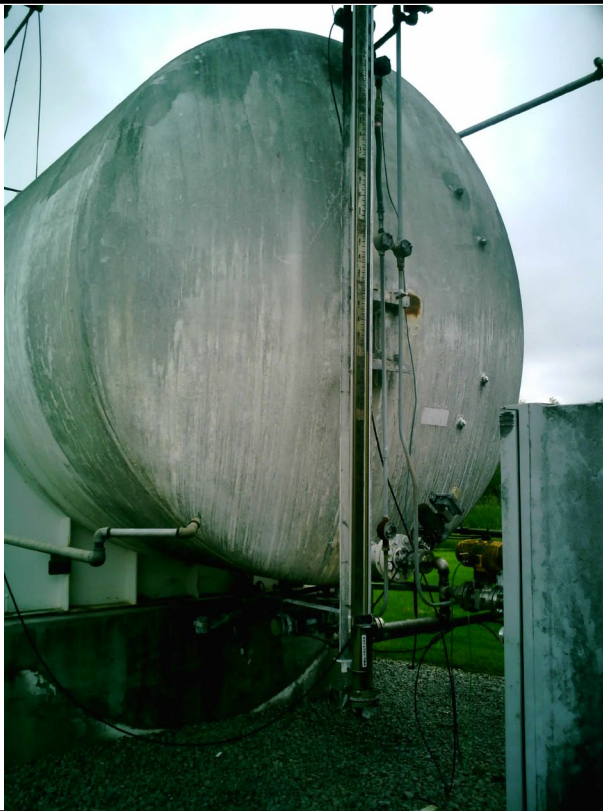
Compliance Evaluation Inspection	DESCRIPTION	Photo looking northeast from southwest end of the trimethylamine storage tank of the spyglass, showing the tank fill level.	Photo 017
	PHOTOGRAPHER	Jodi Harper	Date 06/07/2022

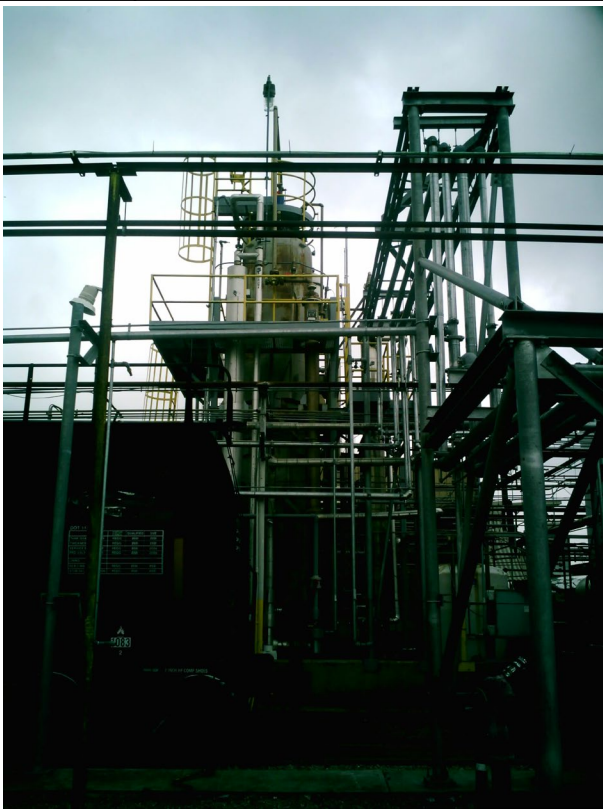
Compliance Evaluation Inspection	DESCRIPTION	Photo looking south from southwest end of trimethylamine storage tank of the reactor vessel where trimethylamine, hydrochloric acid, and ethylene oxide are reacted to form (?)	Photo 018
	PHOTOGRAPHER	Jodi Harper	Date 06/07/2022

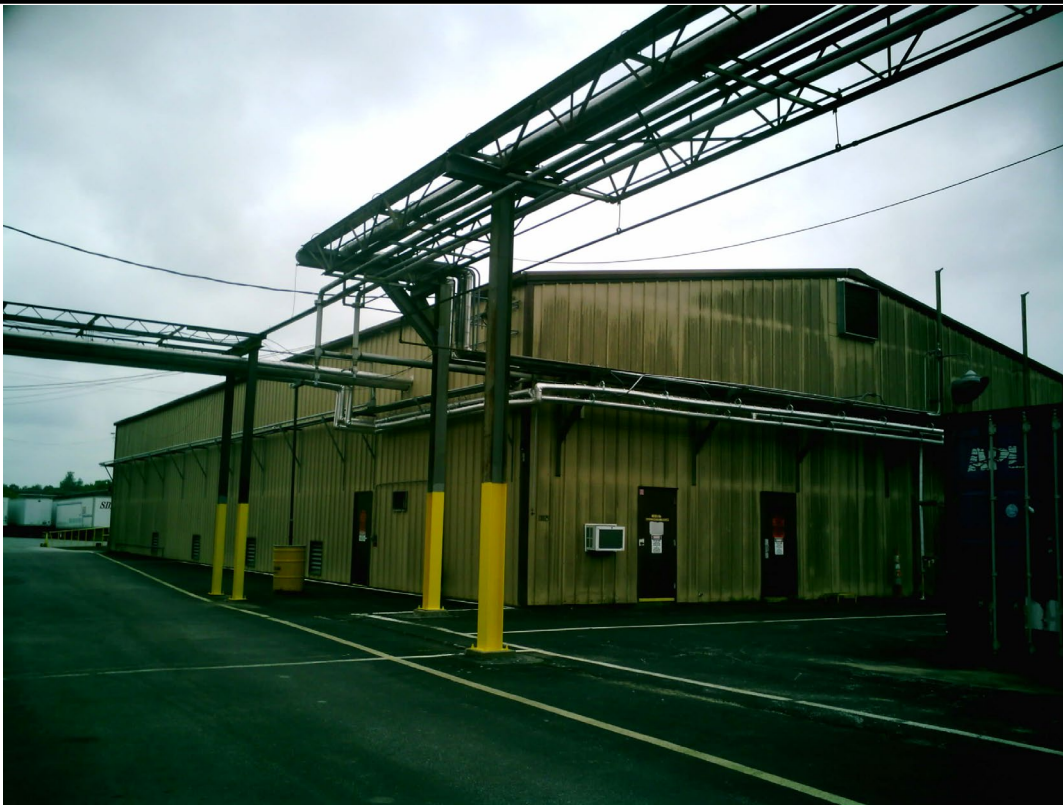
Compliance Evaluation Inspection	DESCRIPTION	Photo looking southwest from intersection northeast of Building V25, showing exterior markings, safety systems, and piping for raw material delivery to the building.	Photo 019
	PHOTOGRAPHER	Jodi Harper	Date 06/07/2022

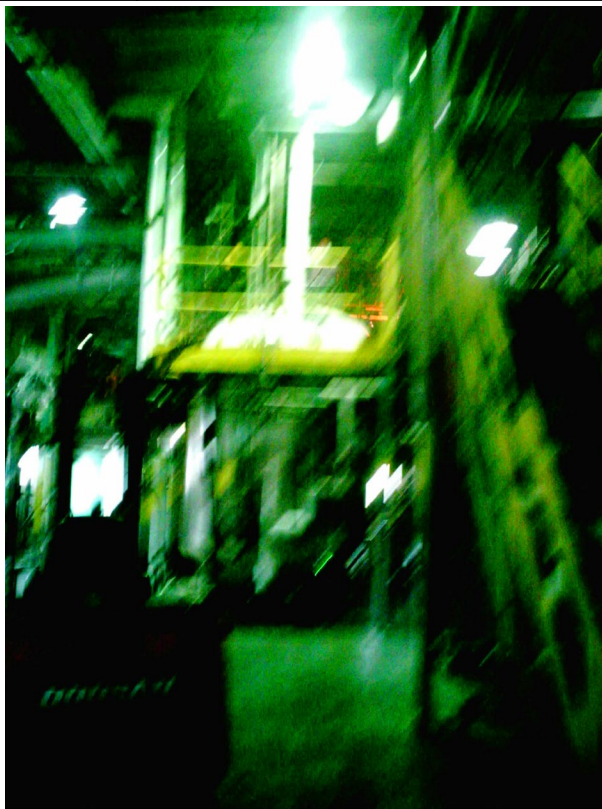
Compliance Evaluation Inspection	DESCRIPTION	Photo looking north from inside Building V10 at the choline chloride manufacturing equipment (blurry)	Photo 020
	PHOTOGRAPHER	Jodi Harper	Date 06/07/2022

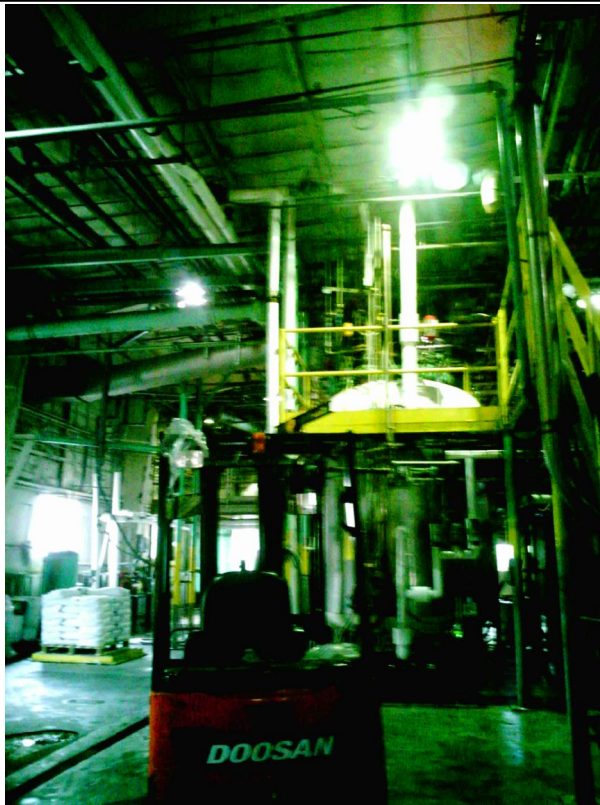
Compliance Evaluation Inspection	DESCRIPTION	Photo looking north from inside Building V10 at the choline chloride manufacturing equipment.	Photo 021
	PHOTOGRAPHER	Jodi Harper	Date 06/07/2022

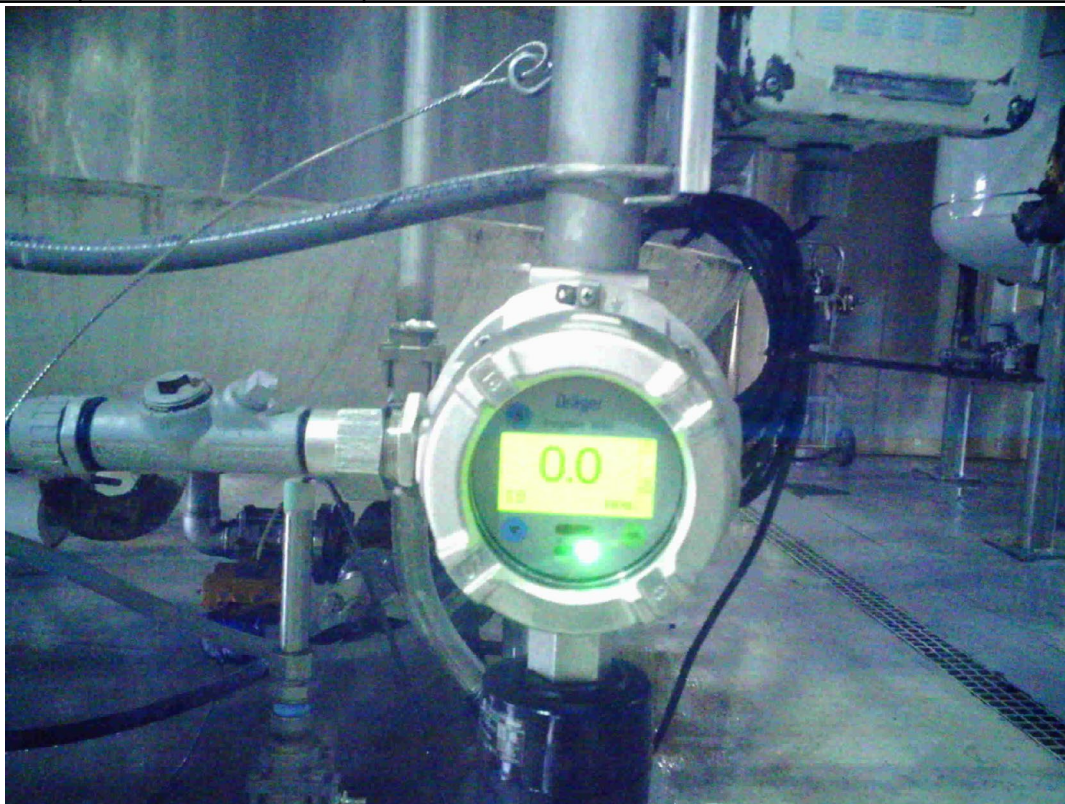
Compliance Evaluation Inspection	DESCRIPTION	Photo looking at ethylene oxide sensor reading of equipment in Photo 021, above. Handheld monitors worn by EPA inspectors had alarmed, with readings above 2.0 ppm; the above monitor read 0.0 ppm.	Photo 022
	PHOTOGRAPHER	Jodi Harper	Date 06/07/2022
